## Road and Railroad Crossing Inventory

Little Coulee

U.S. Department of the Interior  
Bureau of Reclamation  
Great Plains Region  
Dakotas Area Office

September 2005

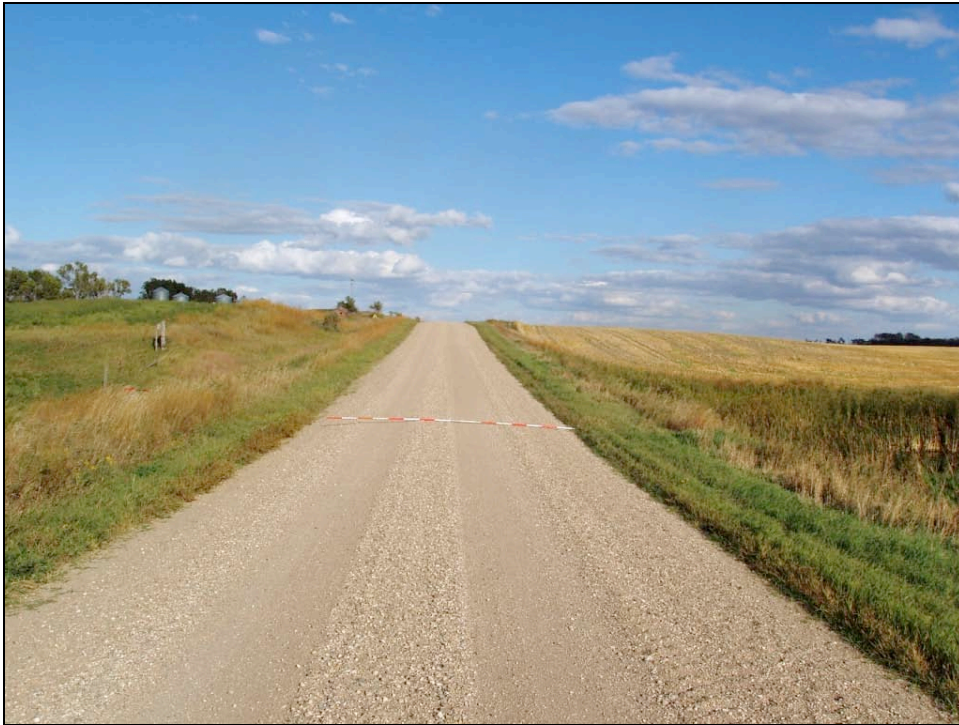
L29 Center of road crossing, across one 84" CMP, looking east, Section 4 & 33, T158 & 159N, R69W, N 564923.32, E 2226323.96, elevation 1565.8 @ center of road crossing, top of gravel.

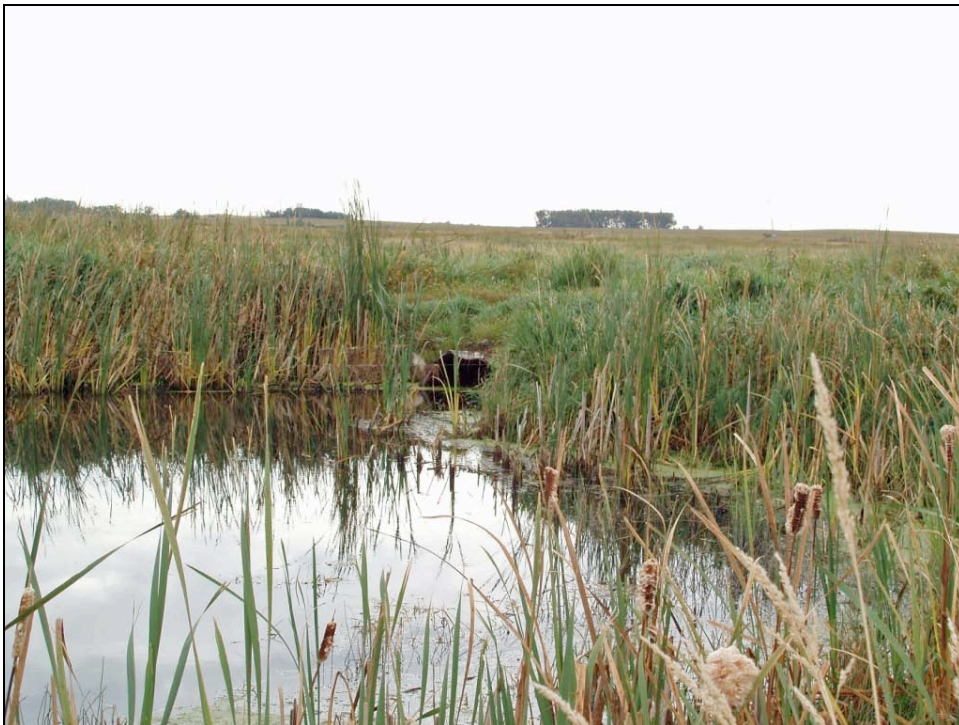
L30 Upstream side of two (48" & 24") CMPs, in fair condition, south to north, 1.7 feet, & 0.1 feet of water (09-14-05), Section 29 & 28, T159N, R69W, N 575117.15, E 2222726.49, elevation 1566.9 @ invert of 48" CMP, N 575132.15, E 2222729382, elevation 1569.4 @ invert of 24" CMP.

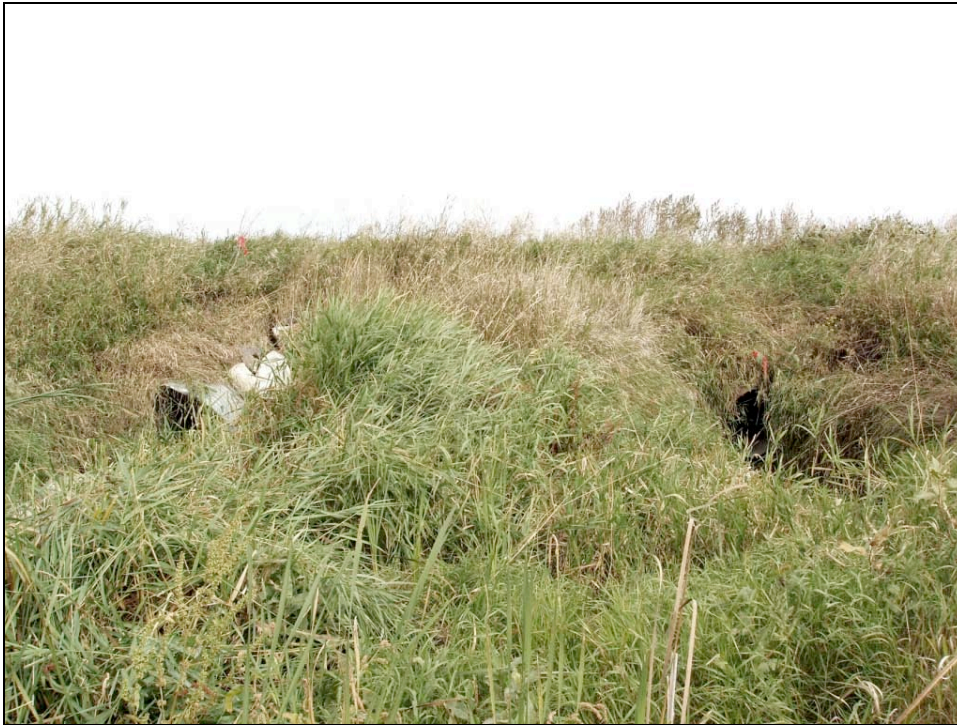
L32 Upstream side of two CMPs (24" & 36") CMPs in good condition, east to west, no water & no water (09-14-05), Section 17 & 20, T159N, R69W, N 580727.52, E 2219605.35, elevation 1576.4 @ invert of 24" CMP, N 580730.56, E 2219594.87, elevation 1575.9 @ invert of 24" CMP.

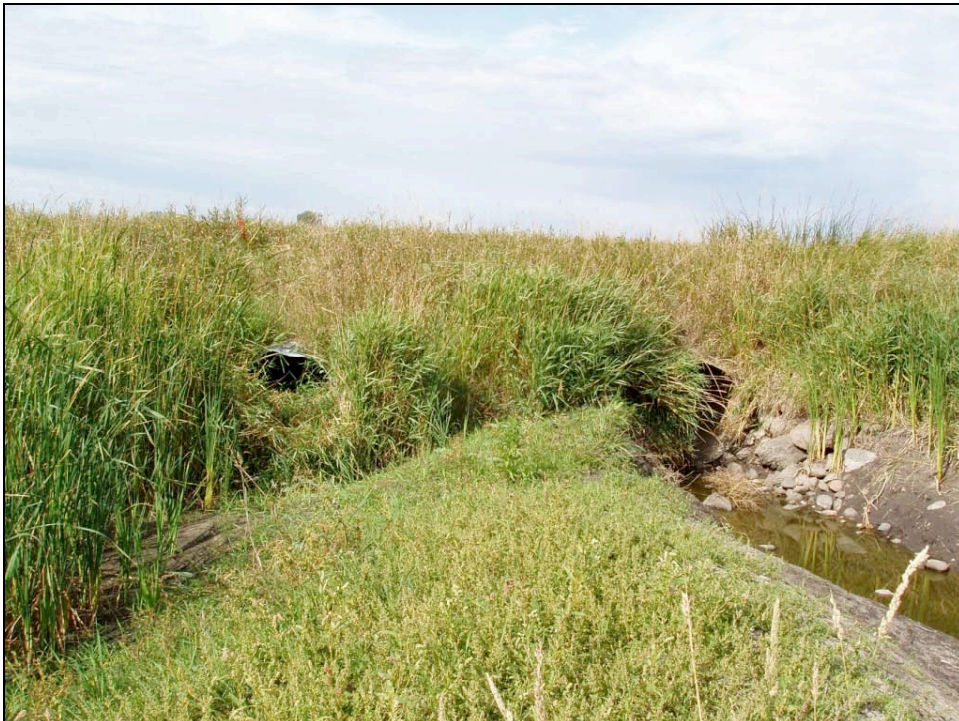
L33 Upstream side of two CMPs (36" & 48"), in good condition, south to north, no water & no water (09-14-05), Section 18 & 17, T159N, R69W, N 581507.09, E 2217352.77, elevation 1582.2 @ invert of 36" CMP, N 581521.94, E 2217352.44, elevation 1580.0 @ invert of 48" CMP.

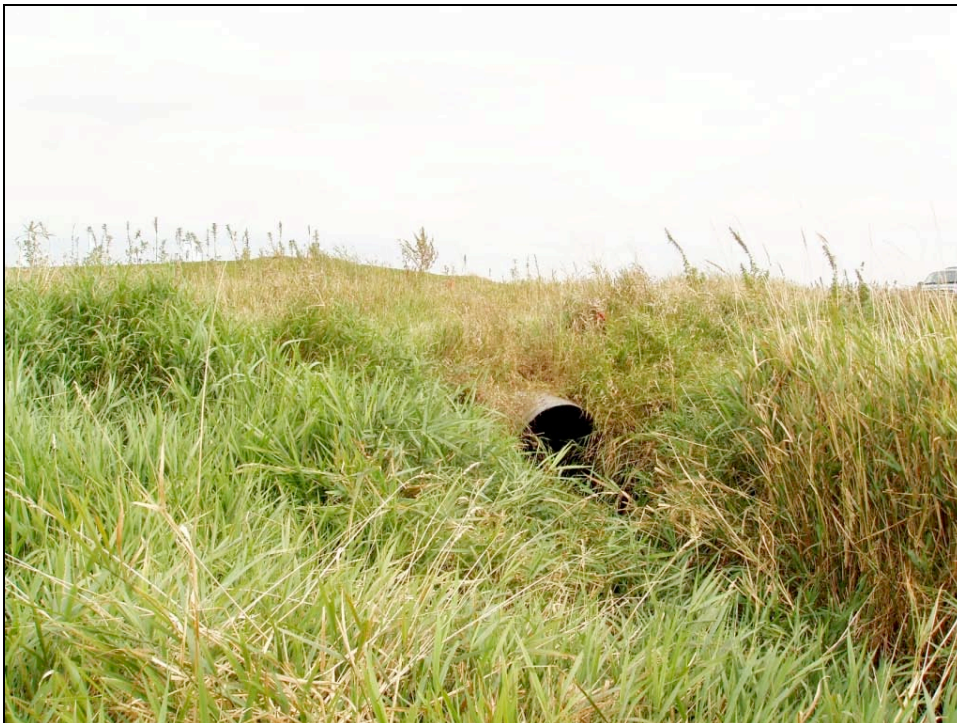
L35 Upstream side of one 48" CMP, in fair condition, 0.6 feet of water (09-14-05), Section 6 & 7, T159N, R69W, N 591227.68, E 2215083.29, elevation 1600.4 @ invert of CMP.

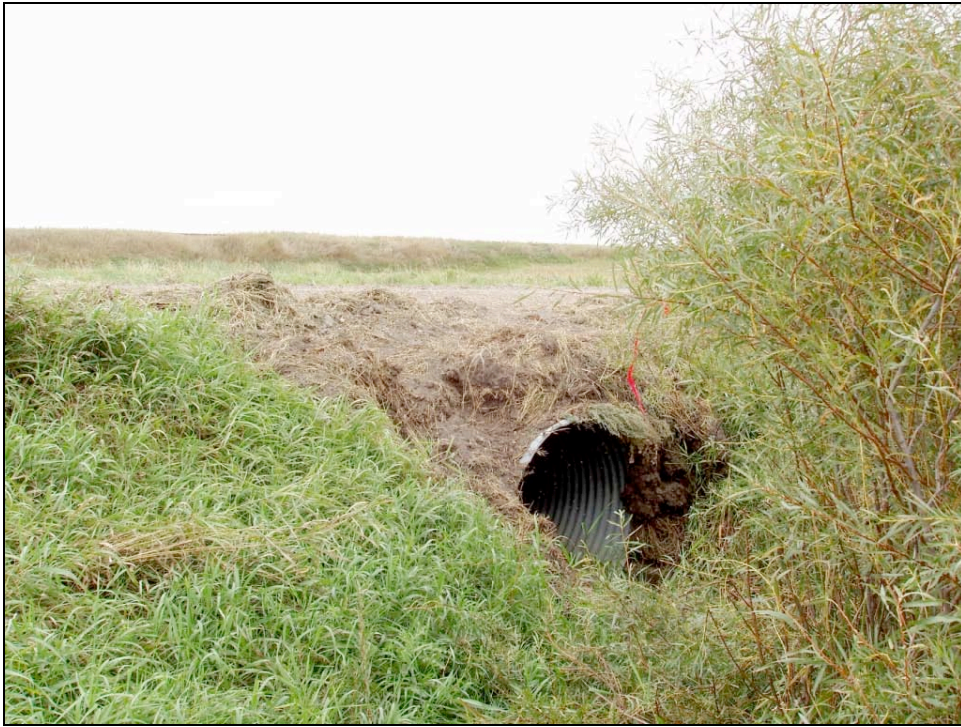
L36 Upstream side of one 48" CMP, in fair condition, 0.2 feet of water  
(09-14-05), Section 31 & 6, T159 & 160N, R69W, N 596531.05,  
E 2215658.84, elevation 1613.5 @ invert of CMP.

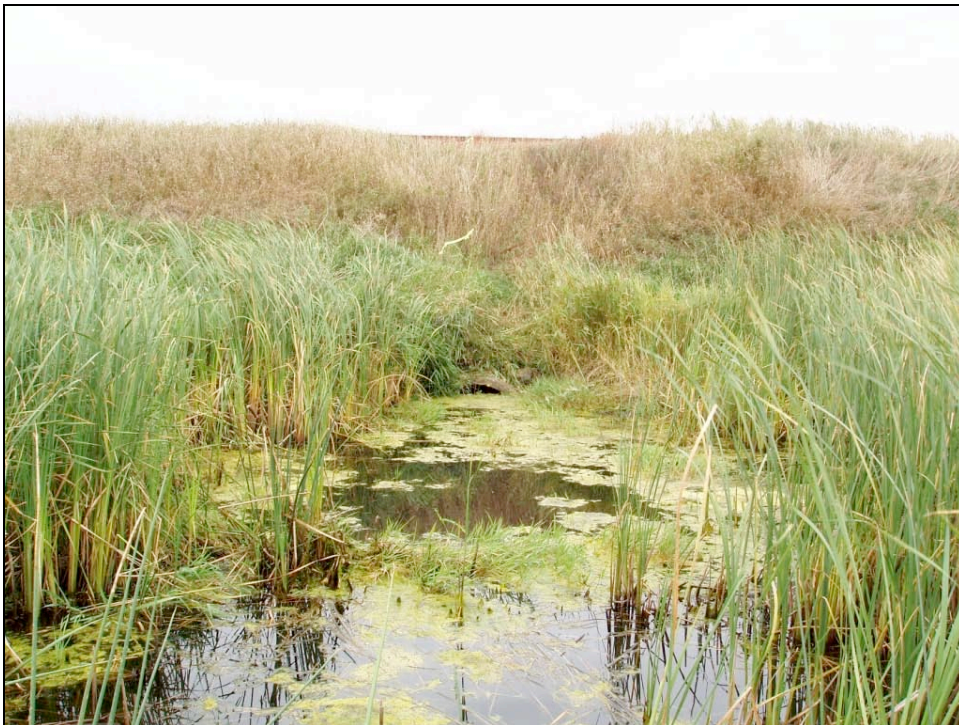
L37 Upstream side of one 48" concrete pipe, in good condition, 3.6 feet of water (09-14-05), Section 31, T160N, R69W, N 596779.07, E 2215819.44, elevation 1612.9 @ invert of concrete pipe.

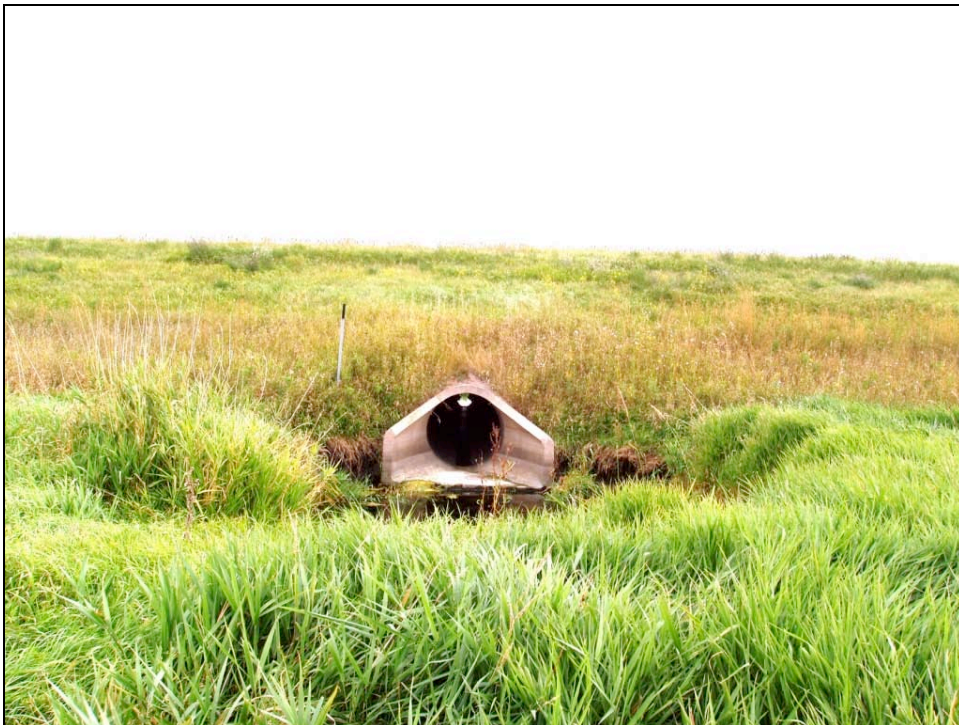
L39 Upstream side of one 48" concrete pipe, in good condition, 0.1 feet of water, Section 31, T160N, R69W, N 597370.64, E 2216239.40, elevation 1620.0 @ invert of concrete pipe.

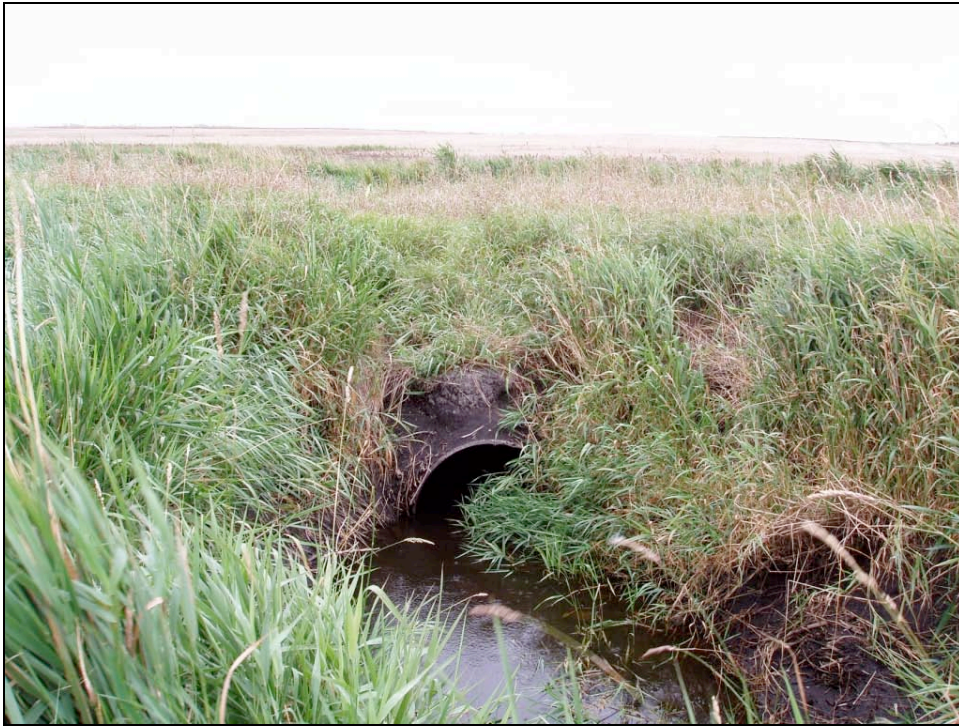
L40 Upstream side of one 36" CMP, in fair condition, 0.2 feet of water (09-14-05), Section 31 & 32, T160N, R69W. N 597877.57, E 2217162.08, elevation 1622.2 @ invert of CMP.
